# Failure Investigation of Piled Reinforcement Soil Wall & Excessive Movements of Piled Embankment at Soft Ground, Malaysia

**ABSTRACT:** This paper presents two case histories covering a collapsed piled supported reinforced soil wall at weak deposits under extreme weather condition and another case of excessive movement of piled road embankment approaches affecting the bridge abutments. The first case history demonstrates an ultimate limit state condition under the most unfavorable meteorological events of which the failure was expected and justified from the design review, whereas the second case shows the problem of the consolidation settlement of working platform resulting free standing condition of the embankment piles with high lateral loading from the non-pile supported approach earth embankment of lower height. Both cases involve the reaching of ultimate lateral pile resistance of the supported structure. Sequence of events established from investigation evidences leading to the failure are illustrated in the paper and remedial solutions are also presented.

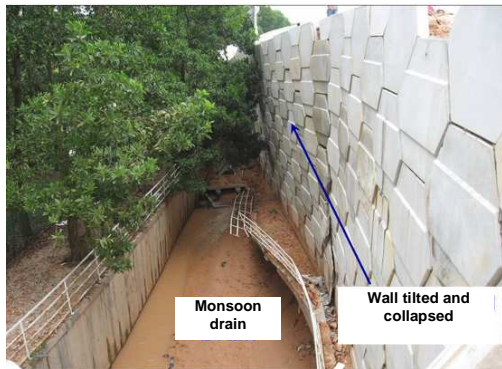
- a. Collapsed retained ground with water stagnation was observed at the tension cracks on the granular backfill and the upper cohesive backfill.

Figure 4 Side view of the collapsed combined wall

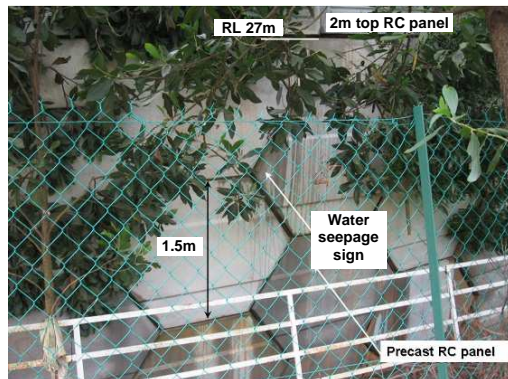
- b. Wet wall panels and traces of watermarks were observed implying evidence of seeping water through the panel joints. The highest level of observed seeping watermarks was at the top of the RS wall indicating high water level behind the wall panels as shown in Figures 4 and 5.
- c. The base slab was still well attached to the laterally translated RS wall. As shown in Figure 6, the upper part of the exposed piles had suffered flexural hinge damage at both the pile head and 1.8m below the slab soffit probably under excessive lateral loading resulting in lateral translation and rotation of piles towards the monsoon drains.

Figure 5 Observed watermarks on wet wall panels

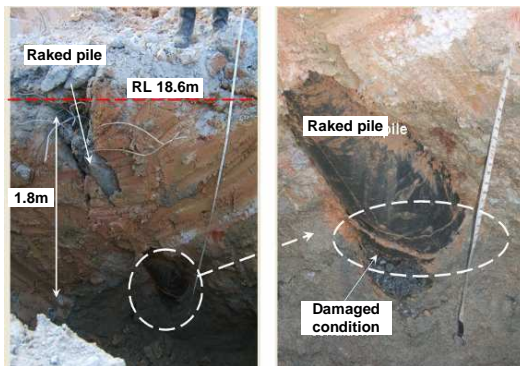
Figure 6 Damaged foundation piles

- a. The foundation pile design, at service groundwater condition, had achieved optimum design requirements with adequate safety factors.
- b. Rise of water table to RL25m after prolonged antecedent rainfall and follow by a triggering rainfall induced excessive lateral force on the foundation piles supporting the combined walls, in which the ultimate limit condition was reached.
- c. Excessive imposed lateral stress exceeded the ultimate lateral resistance of the foundation piles resulting in the collapse of central portion (CH40-CH70) of the combined wall and pulling the adjoining wall from both ends.

- a. Dismantle the collapsed combined wall and demolish the original RC slab,
- b. Replace the disturbed weak foundation soils with crusher run,
- c. Install 6 rows of new offset raked and vertical foundation piles,

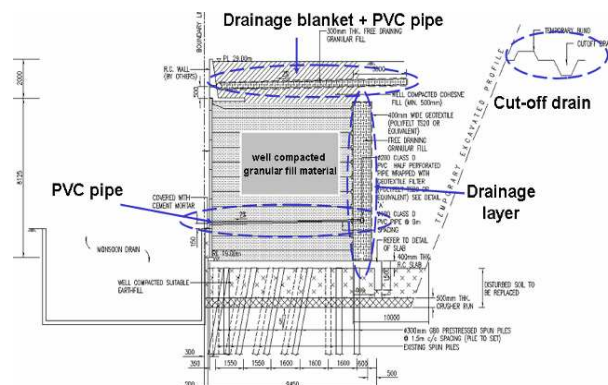
Figure 7 Cross section view of remediated combined wall

- d. Construct new RC slab with same reinforcement details and reinstate damaged monsoon drain,
- e. Re-erection of RS wall with additional weepholes, horizontal drainage pipes and drainage layer behind the wall panels. Additional weepholes and horizontal drainage pipes were also introduced to the intact wall survived in the failure incident,

- f. Re-erect the new RS wall with free draining backfill materials and top compacted cohesive fill for the upper RC wall,
- g. More proper construction controls and precautionary measures such as temporary cut-off drains of larger capacity, sequence and compaction of backfill granular material and close monitoring works on both intact and re-erected RS wall were carried out. Figure 7 shows the cross sectional view of the remediated wall.

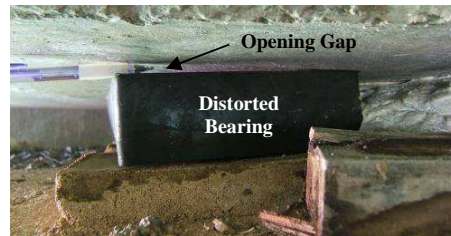
- First failure occurred at the PVD treated area immediately next to the piled approached embankment after the embankment fill was completed 6 days later.
- Subsequently, development of tension cracks leading to sudden collapse of embankment fill was reported at the EVD treated area and the adjoining piled embankment after reaching 5m fill height.
- Thereafter, spalling of concrete and gap opening at the bridge deck near Abutment B were observed.
- After the failure of EVD embankment and piled embankment, most electrometric rubber bearings at Abutments A and B suffered observable shearing deformation as shown in Figure 9.
- From the bridge bearing distortion at abutments and piers, it was confirmed that there was clockwise rotation on plan and

Figure 9 Shearing distortion of rubber bearing

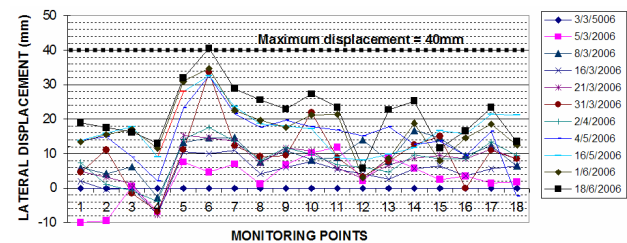
global lateral movement of the bridge deck in the direction from Abutment B towards Abutment A. Bridge movement monitoring layout in Figure 10 revealed maximum bridge movement of 40mm in longitudinal direction as show in Figure 11. However, movement of the bridge before commissioning the monitoring works was not registered.

Figure 11 Movements in the longitudinal direction

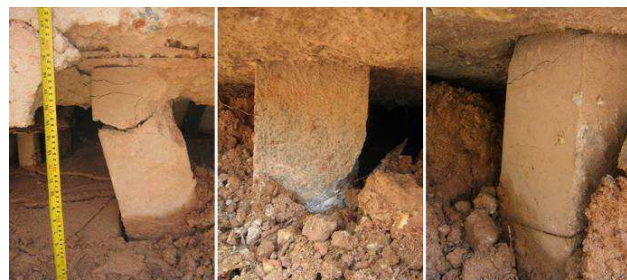
- As shown in Figure 12, the filled piling platform has settled about 400 to 1000mm in magnitude beneath the piled RC slab and flexural cracks were observed at numbers of free standing piles at the piled embankments.
- Slab of piled embankment was damaged and the slab movement led to 100mm gap at joints of the slab.

Figure 12 Settlement of piling platform and flexural damage of embankment foundation piles

For the remedial design, it was crucial to simultaneously remove the active lateral earth pressure behind both abutments to avoid unbalanced lateral loading and replace with geotextile reinforced backfill preventing lateral load from imposing to the abutments. The embankment removal and reconstruction were closely monitored using the movement markers. As for the distressed pile embankment structure, it was suggested to demolish and reinstall with new piles and RC slab for the embankment height exceeding 2.5m.

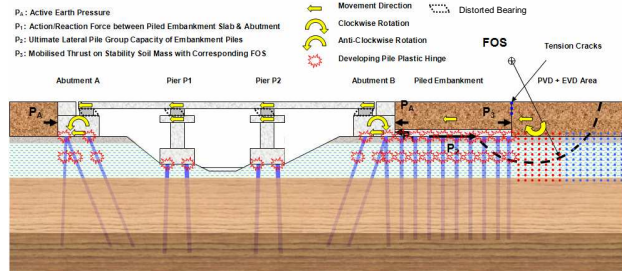
embankment could have also imposed excessive flexural stress to the RC piles. The net horizontal thrust after deducting the lateral resistance of the group piles beneath the embankment then pushed Abutment B, bridge decks and Abutment A. The bearing distortion shape agrees well of the load path traversing from the Abutment B through bridge decks and the piers and finally reaching Abutment A. A schematic diagram of such scenario is shown in Figure 13.

Figure 13 Schematic bridge movements

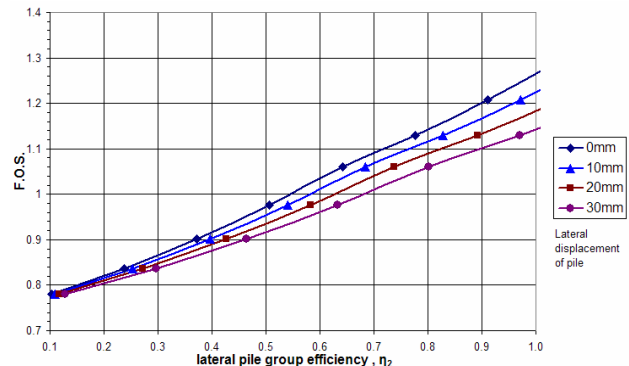
Assuming both abutment piles and piled embankment foundation piles had reached the ultimate pile group capacity, the safety factor of the embankment stability in longitudinal direction is at best 1.14 to 1.26 depending on the pile eccentricity due to lateral displacement. Creeping foundation movements due to occurrence of plastic deformation of underlying weak subsoil will cause unacceptable serviceability conditions of piles and gradually undermine the structural integrity of the bridge structure. In fact, the entire system including the bridge, pile embankment and the embankment was at the marginally stable condition with very low safety factor. The summary of the safety factor of the embankment stability at the PVD and EVD treated embankment behind the piled embankment with consideration of the pile eccentricity effect as shown in Figure 13 is presented in Figure 14.

Figure 14 Safety factor of embankment stability with lateral pile group efficiency and pile eccentricity effect
