# Investigation of Soil Nailed Slope Distress at Fill Ground & Remedial Solutions

**ABSTRACT:** This paper presents a case history of a distressed 6m to 10m high soil nailed slope formed for basement excavation at fill ground over a natural valley. Above the soil nailed slope, there is an existing 8m to 11m high reinforced soil wall, located 23m away from the soil nailed slope. During the early stage of excavation for soil nailing works, distresses like ground surface cracking and settlement were observed. Perched groundwater at the natural valley during the heavy monsoon season posed further difficulties to the drilling works and induced instability in the steep excavated face of the fill materials. As such, a well planned instrumentation programme was implemented to monitor the construction safety of the on-going soil nailing works. Remedial solution using permanent steel sheet pile wall with two rows of soil nail anchorages is presented in this paper. The performance of the remedial works through instrumentation results and design verification tests of nailing are presented to illustrate their effectiveness and satisfactory performance even with the adverse rainfall event.

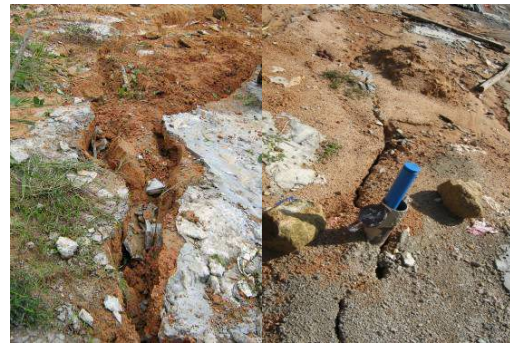
Figure 3 Tension cracks at the crest of the soil nailed slope

Immediate mitigation action was promptly taken at site by constructing a passive berm in front of the slope and seal up the tension cracks using bentonite-cementitious grout slurry to stop infiltration of the surface runoff when the first surface slip failure happened on 1<sup>st</sup> April 2008. Inclinometer monitoring frequency had been revised to daily basis to closely monitor the distressed slope behaviour and also monitor the daily site activities which might potentially further endanger the slope. Soil nailing contractor was also instructed to rectify the cave-in collapse with sand bricks and cement grouts as dental filling.

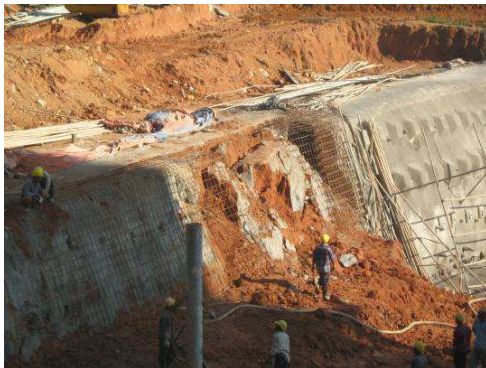
Figure 2 Localised surface slips occurred during soil nailing work

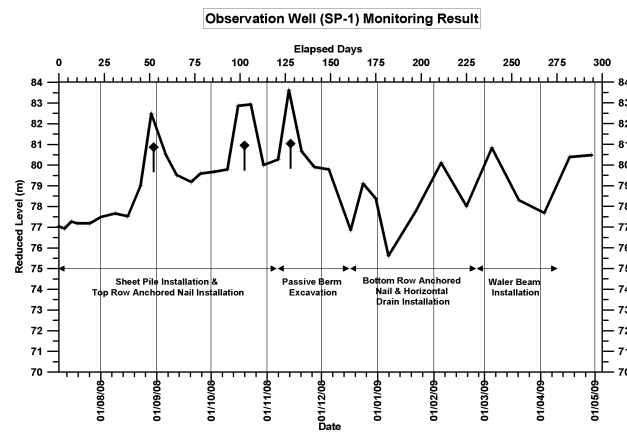
Two observational wells (SP-1 and SP-2) were installed in July 2008 to measure groundwater level on a weekly basis during the period of unexpected prolonged rain storm between March and April 2008 (Figure 6). Monitoring results of SP-1 (Figure 7) located at slope crest showed that groundwater levels changed erratically indicating rain storms during the construction of soil nailed slope especially between August and December 2008. Surface runoff filled up the tension cracks and created perched groundwater. The excavated bare slope was susceptible to shallow surface collapse after saturated by water.

Figure 7 Fluctuation of water level with time

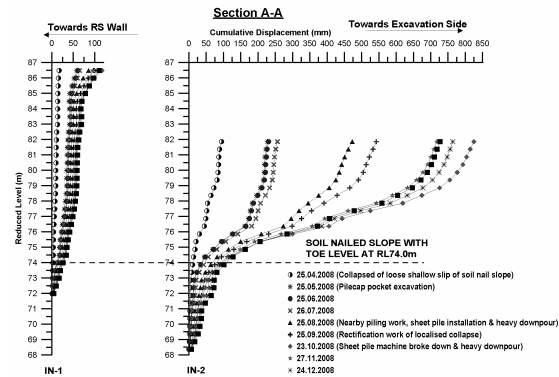
Slope movement was first detected in April 2008. IN-1 and IN-2 indicated lateral creeping of the slope. Site assessment was immediately carried out to investigate the causation of slope creeping. Preliminary suspicion was attributed to the pocket excavation of pilecaps which were located less than 500mm away from the slope toe. Torrential rain further aggravated the slope movement. Perennial surface collapse and tension cracks at slope crest were noticed as the bare cut slope left unattended by the site team and only focusing on rushing the construction of substructure works. Figure 8 and 9 show inclinometers monitoring results (IN-1, IN-2 and IN-5 respectively) corresponding to the various activities triggering the distressed slope to creep laterally. Tension crack mapping was shown in Figure 10 and displacement markers indicated that the distressed slope formed a bowl-shape unstable slope mass.

Figure 8 IN-1 and IN-2 monitoring results at Section A-A

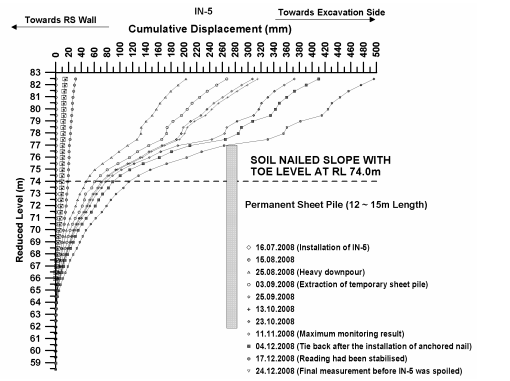
Figure 9 IN-5 Monitoring results

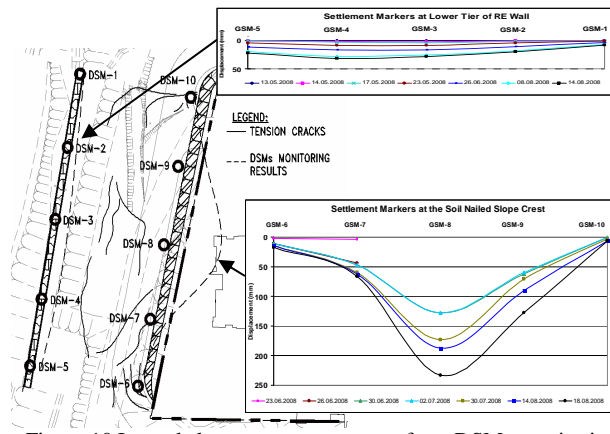
Figure 10 Lateral slope creep movements from DSMs monitoring results and tension cracks

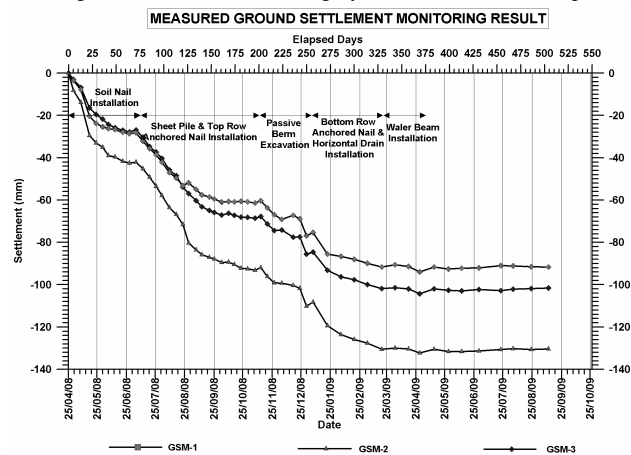
The slope was further disturbed due to the vibration of sheet pile penetration agitating the loose fill. Air flushing in the open-hole drilling using high compressed air by portable spider drilling rig had also been modified by using water flushing technique with protective casing to minimise the soil disturbance in the anchor nails installation. Due diligence was exercised by the contractor in handling the construction at this highly sensitive distressed slope.

Figure 11 Measured ground settlements

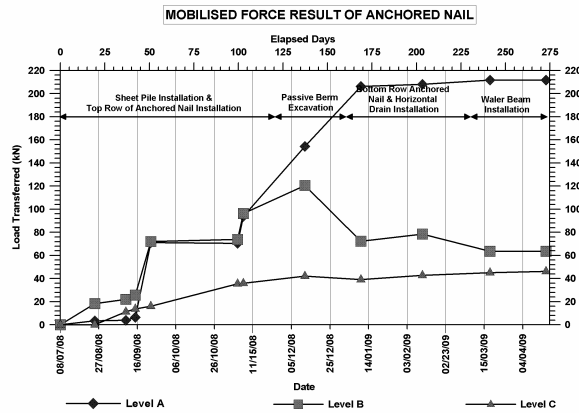
An instrumented anchor nail was installed at the top row of anchored nails to be monitored on fortnightly and monthly basis during the anchored nails installation and further excavation stages. The setting out of vibrating wire strain gauges was shown in Figure 13 and the mobilized force of the instrumented anchored nail was presented in Figure 14. The results indicated the top row nail started to gradually mobilise as a result of earth pressure after progressive removal of passive berm for the installation of bottom row anchored nails. The monitoring results indicated that the anchored nail had mainly mobilized the nail resistance from Level A to B. It is clearly evidenced that the unstable slope mass transferring most of the unbalanced force to the sheet pile wall. The subsequent anchored nail performance had evidenced that the remedial solution had successfully arrested the potential failure.

Figure 14 Mobilised force result of instrumented anchored nail

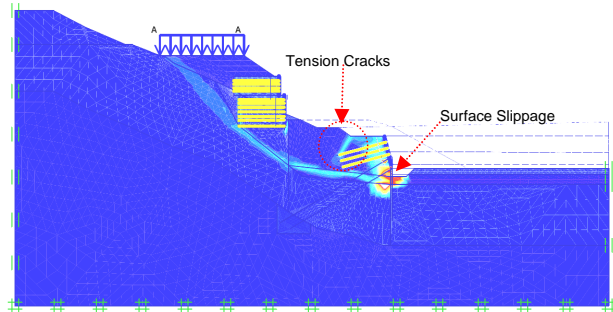
The FEM results confirmed the zoning with high shear strain within the unstable slope mass tally reasonably well with the occurrence of tension cracks location as depicted in Figure 15. A band of potential slip surface was developed in the form of semi circular failure and cutting through the earlier installed nails. The analysis also showed the potential circular slip which was similar to the one detected from the inclinometer results. The  $c$ - $\phi$  reduction method was also performed to confirm the said local potential failure surface. In such cases, the permanent sheet pile with approximately 12 to 15m is essentially required to provide sufficient resistance to maintain the equilibrium and arrest the slope lateral movement.

Figure 15 High shear strain area showing potential locations of tension cracks and potential slip surface developed during pilecap pocket excavation
