# Failure Investigation of Crib Wall, Piled Reinforced Concrete Wall And Geosynthetic Reinforced Soil Wall

**ABSTRACT:** This paper presents two case histories on the collapse of 10m high crib wall with 4m high piled reinforced concrete wall on top and excessive creep movement of 3m high geosynthetic reinforced soil wall. In both cases, the walls were built to retain a filled batter slope with gradient of 1V:1.5H. Investigating processes consisting of site reconnaissance, topography survey, subsurface investigation, laboratory testing and assessment of both external and internal wall stabilities will be briefly discussed in this paper. Rainfall records spanning the period before failure incident were gathered to reveal the relationship between the failure and the rainfall. This paper also presents the ineffectiveness of reinforced concrete (RC) piles in taking bending moment and lateral load from earth pressure. Finite element analyses were also performed to verify the inherent failure mechanism of the lower crib wall, the upper piled reinforced concrete wall and the geosynthetic reinforced soil wall. In addition, remedial solutions are also presented in this paper to demonstrate

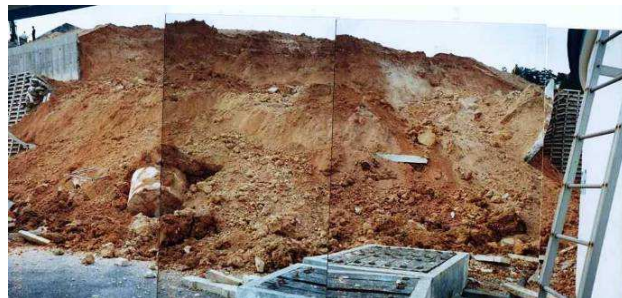
Figure 1 Collapsed Crib Wall and Piled RC Wall

In March 2006, a newly constructed crib wall with piled reinforced concrete (RC) wall seated atop collapsed during a raining season in Kuala Lumpur, Malaysia. The crib wall, piled RC wall and backfilled batter slope (about 62m long) with total height of about 15m had been built at the site to retain the building platform at reduced level RL 213.13m. The 3 headers crib wall at the collapsed section has a height of about 9.4m to 10.6m. A 4m high piled reinforced concrete (RC) wall was constructed on top of the crib wall with an offset of 4m away from the crib wall. The RC wall was built with a 2.4m width base and supported by two rows of vertical 150 x 150mm RC square piles at 1.25m centre-to-centre spacing. A filled batter slope with gradient of 1V:1.5H was then constructed above the RC wall. Figure 1 shows the condition of the collapsed crib wall and piled RC wall whereas Figure 2 shows the subsurface investigation (SI) layout plan.

- In view of insufficient FOS of the cribwall against sliding, the collapse of the crib wall likely occurred prior to the RC wall, in which the ribs of the crib wall were found at the front portion of the collapsed debris.

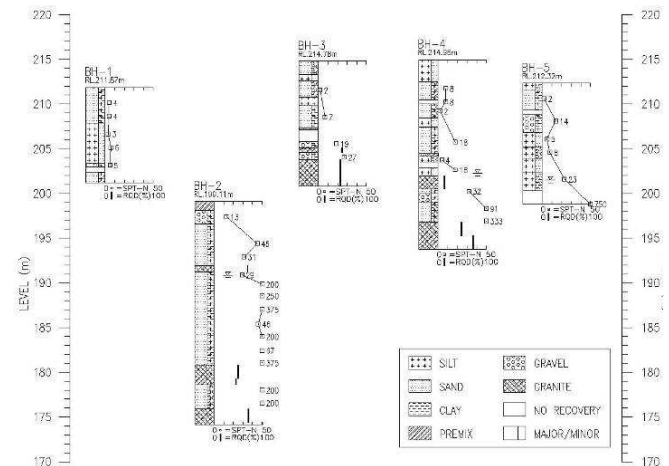
Based on the Geological Map of Selangor, Sheet 94 Kuala Lumpur published by the Geological Survey Department, the site is underlain by Granite formation. Generally, the subsoil strata below the wall backfill consist of a layer of weathered residual soils with primarily silty SAND and sandy SILT overlying the granite bedrock

as shown in Figure 3. Whilst the backfilled material with average SPT-N values of 5 was found on top of the residual soils.

Figure 3 Subsoil Profile

- The low SPT-N values observed at the backfilled layer indicated that fairly poor compaction was achieved during construction. The dry density of undisturbed samples of BH1-UD1, BH1-MZ1 and BH3-UD2 ranges from 1.323Mg/m<sup>3</sup> to 1.511Mg/m<sup>3</sup>, which was only about 80% of the maximum dry density obtained from standard Proctor test. Therefore it was evidenced that the backfill material had not been compacted to fulfil the normal engineering fill requirement at site and thus infiltration of surface runoff into backfill can be reasonably expected.

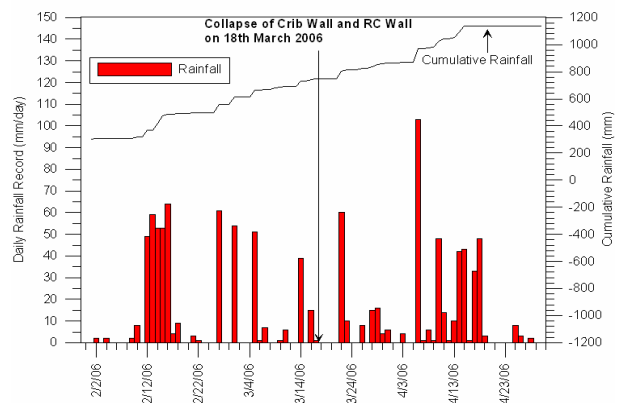
Figure 6 Rainfall Data

- The FOS against sliding on the crib wall without considering groundwater table is marginally lower than 1.0. When groundwater is at 1/3 of the wall height, the sliding resistance of the crib wall is even lower. Therefore, the collapse of the cribwall was most probably triggered by the rise of groundwater table behind the wall backfill. This can be evidenced by the rainfall record as shown in Figure 6, which indicated high volume of antecedent rainfall before the collapse. The impact of antecedent rainfall will cause gradual rise of groundwater table reducing the wall stability.

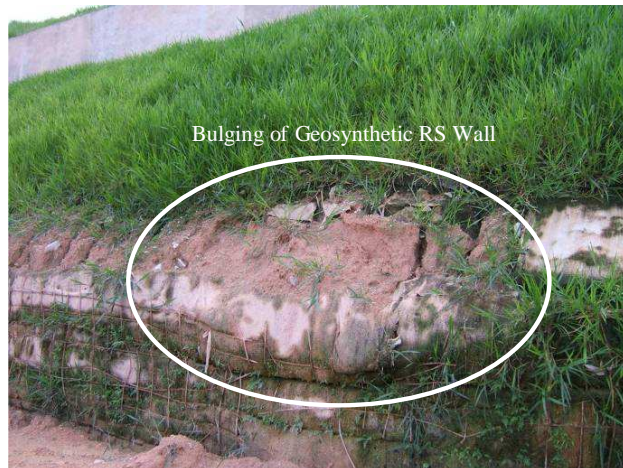
Figure 8 Bulging of Geosynthetic RS wall

- Bulging and outward movements of the geosynthetic RS wall at the lowest berm were observed as shown in Figure 8. The bulged wall alignment had encroached into the property boundary. In addition, it was also observed from site inspection that the wall surface was very wet.

- Although lower FOS does not imply that the geosynthetic RS wall and slope will fail, large creeping movement of the wall and slope could be expected, which may exceed the serviceability limit and certainly can not be captured by the limit equilibrium analyses. The finite element analysis had actually shown large movement of the geosynthetic RS wall.

- Install 10 rows of soil nail with various lengths ranging from 6 to 12m to strengthen the batter slope. The batter slope was then protected by a layer of shotcrete.
- Subsequently, trimming of the bulged geosynthetic RS wall by removing the excessive soil and re-wrapping of the geotextile.
- Constructing a 4m high RC wall by casting the concrete against the geosynthetic RS wall to retain the soil and batter slope.
- Provision of proper drainage system including subsoil drains and berm drains.

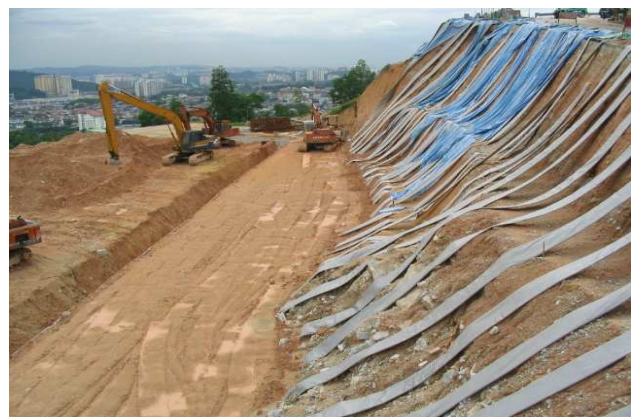
- A layer of strip drain was laid on the collapsed temporary cut slope prior to the construction of geosynthetic RS wall as shown in Figure 10.
- The backfill materials for the geosynthetic RS wall consist of high moisture content as shown in Figure 11.

Figure 10 Laying of Strip Drain

- The finite element analysis also revealed that the use of closely spaced strip drain behind the geosynthetic RS wall and batter slope will promote tendency of developing preferential slip surface and induce further instability to the geosynthetic RS wall and slope, thus lowering the FOS. This is due to the reason that the interface friction between the strip drain and soil is lower than internal friction between soil particles.

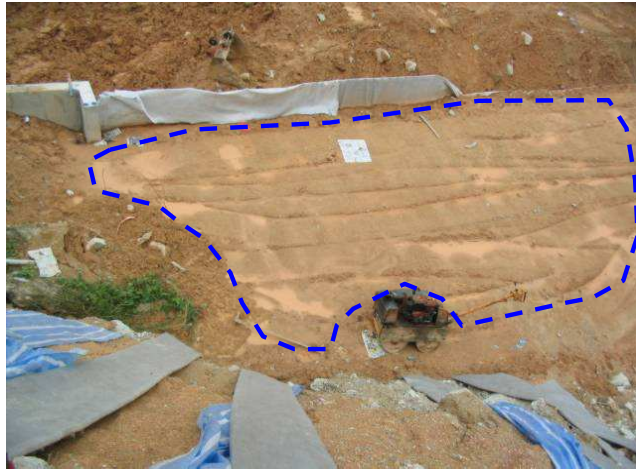
Figure 11 Wet Backfill Material

- The rainy weather continued to prevail during the construction of the geosynthetic RS wall and batter slope. Therefore, it can be reasonably expected that the compaction to achieve the required compaction effort was difficult due to high moisture content of the fill material.
