# Failure Investigation of Piled Reinforcement Soil Wall & Excessive Movements of Piled Embankment at Soft Ground, Malaysia

**ABSTRACT:** This paper presents two case histories covering a collapsed piled supported reinforced soil wall at weak deposits under extreme weather condition and another case of excessive movement of piled road embankment approaches affecting the bridge abutments. The first case history demonstrates an ultimate limit state condition under the most unfavorable meteorological events of which the failure was expected and justified from the design review, whereas the second case shows the problem of the consolidation settlement of working platform resulting free standing condition of the embankment piles with high lateral loading from the non-pile supported approach earth embankment of lower height. Both cases involve the reaching of ultimate lateral pile resistance of the supported structure. Sequence of events established from investigation evidences leading to the failure are illustrated in the paper and remedial solutions are also presented.

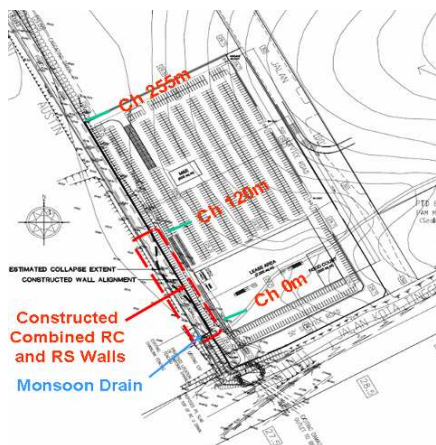
Figure 1 Layout plan of the RS wall

The project site is located within a new residential and commercial mixed development at the southern region of Peninsular Malaysia. The collapsed structure is a combined 2m high reinforced concrete (RC) wall sitting atop a 8m high reinforced soil (RS) wall supported on 400mm thick RC slab and six rows of  $\phi 300$ mm driven prestressed spun concrete piles at weak thick alluvium deposits overlying a more competent very hard residual soils. The 255m long combined wall was constructed as the building platform at RL29m for a commercial complex in which there is a 3.5m deep and 6.5m wide monsoon drain in front of the wall. The soffit of 400mm thick RC slab is at about RL18.6m, whereas the invert of monsoon drain varies from RL16.5m to RL 17.5m towards upstream. Figures 1 and 2 show the layout plan of the project site and cross section of the combined wall respectively.

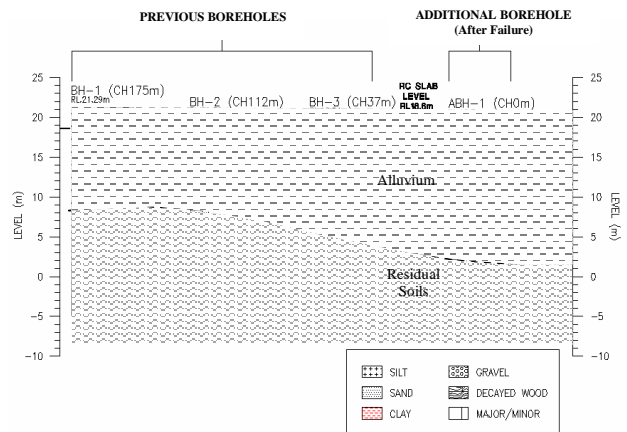
Figure 3 Subsoil conditions of the site

Generally, fill consisting of medium stiff to stiff clayey SILT and clayey SAND (N=6 to 10) was found at the top 4 to 5m below the initial platform at RL20m. Subsequently, very soft to soft CLAY material (Su=40kPa) of about 4m thick was detected overlying a stiff to very stiff sandy SILT (N=10 to 30) of about 10m thick. The groundwater level fluctuated between RL14.0m and RL18.0m. The subsail profile and soil conditions of the project site are summarised in Figure 3.

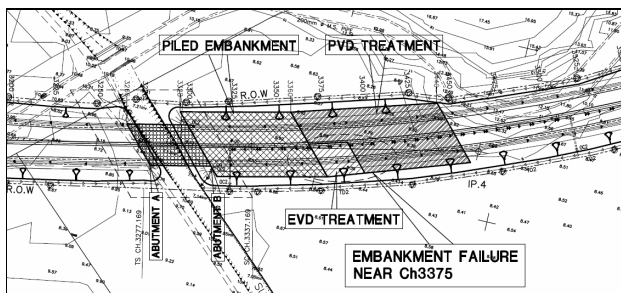
Figure 8 Layout of distressed bridge abutments and embankment

Figure 8 shows the layout of distressed piled embankment and the embankment on two ground treatment techniques near Ch 3375.

- First failure occurred at the PVD treated area immediately next to the piled approached embankment after the embankment fill was completed 6 days later.
- Subsequently, development of tension cracks leading to sudden collapse of embankment fill was reported at the EVD treated area and the adjoining piled embankment after reaching 5m fill height.
- Thereafter, spalling of concrete and gap opening at the bridge deck near Abutment B were observed.
- After the failure of EVD embankment and piled embankment, most electrometric rubber bearings at Abutments A and B suffered observable shearing deformation as shown in Figure 9.
- From the bridge bearing distortion at abutments and piers, it was confirmed that there was clockwise rotation on plan and
