# Investigation of Soil Nailed Slope Distress at Fill Ground & Remedial Solutions

**ABSTRACT:** This paper presents a case history of a distressed 6m to 10m high soil nailed slope formed for basement excavation at fill ground over a natural valley. Above the soil nailed slope, there is an existing 8m to 11m high reinforced soil wall, located 23m away from the soil nailed slope. During the early stage of excavation for soil nailing works, distresses like ground surface cracking and settlement were observed. Perched groundwater at the natural valley during the heavy monsoon season posed further difficulties to the drilling works and induced instability in the steep excavated face of the fill materials. As such, a well planned instrumentation programme was implemented to monitor the construction safety of the on-going soil nailing works. Remedial solution using permanent steel sheet pile wall with two rows of soil nail anchorages is presented in this paper. The performance of the remedial works through instrumentation results and design verification tests of nailing are presented to illustrate their effectiveness and satisfactory performance even with the adverse rainfall event.

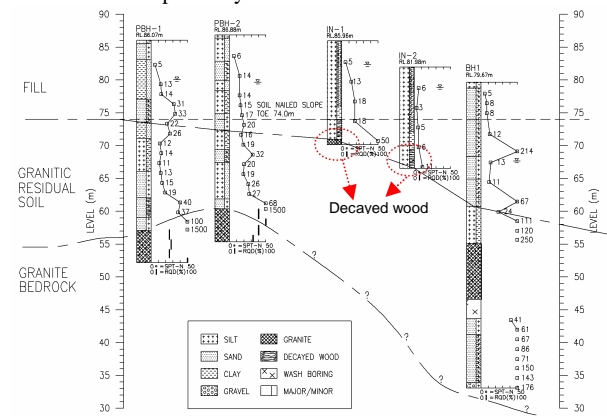
Figure 4 Boreholes profiles

Information obtained from the nearest exploratory boreholes to the soil nailed slope area revealed that the subsoids mainly consist of clayey SAND and sandy SILT with SPT-N values ranging from 5 to 33 (denoted by PBH1, PBH2 and BH1 in Figure 4). A hard layer can be found at about 13m below the soil nailed slope toe. The shear strength parameters obtained from the undisturbed samples at the granite residual soil revealed that the average values of  $c'$  and  $\phi'$  are 5kPa and 31° respectively.

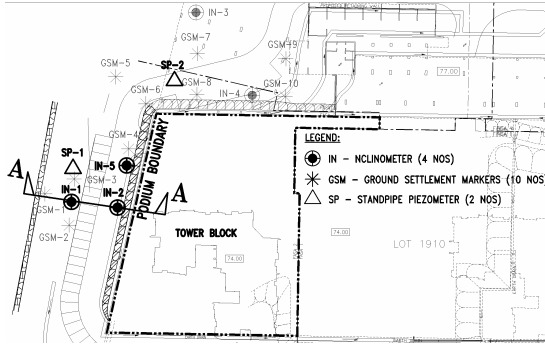
Figure 5 Instrumentation layout

Prior to the construction of the soil nailed slope, two inclinometers (namely IN-1 and IN-2) were installed to monitor the nailed slope performance as a precautionary measure during the construction period. The inclinometer monitoring was carried out on fortnightly basis. At the same time, ten numbers of ground

settlement markers were also installed to monitor the ground settlement as shown in Figure 5. An additional inclinometer (IN-5) was installed after the nailed slope suffered distressing. Undisturbed samples were collected during the installation of IN-5 and two numbers of multiple-reverse direct shear box tests were performed on the reconstituted soil samples. The interpreted residual shear strength of the retained soils was approximately  $c' = 0$  kPa and  $\phi' = 18^\circ$ , which were used for remedial design.

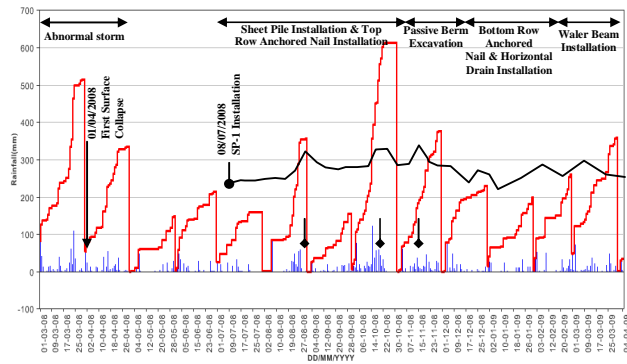
Figure 6 Hyetograph for Kuala Lumpur Rain Gauge Station

Two observational wells (SP-1 and SP-2) were installed in July 2008 to measure groundwater level on a weekly basis during the period of unexpected prolonged rain storm between March and April 2008 (Figure 6). Monitoring results of SP-1 (Figure 7) located at slope crest showed that groundwater levels changed erratically indicating rain storms during the construction of soil nailed slope especially between August and December 2008. Surface runoff filled up the tension cracks and created perched groundwater. The excavated bare slope was susceptible to shallow surface collapse after saturated by water.
